# Home Inspection Report

**8605 Same Ct.  
Indianapolis, In 46217**

Date: February 18, 2012

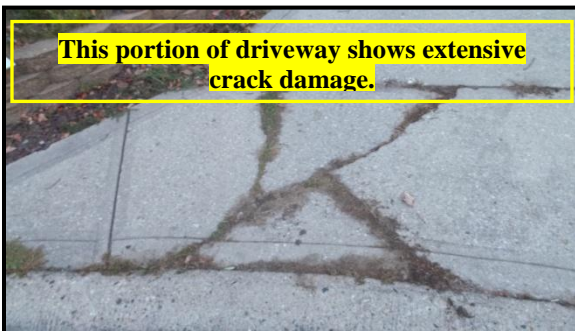
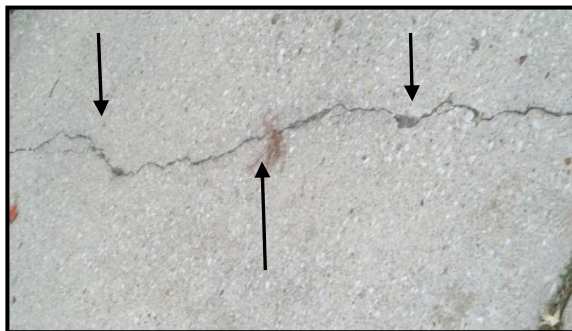
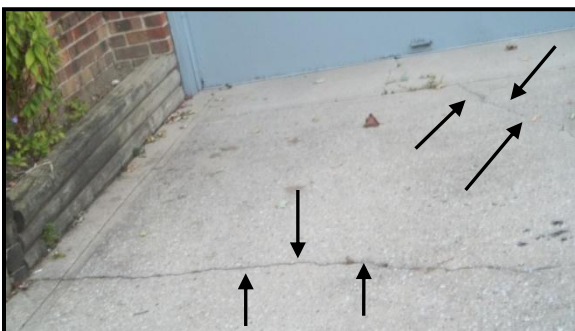
Driveway

**Comments:** Many cracks were found throughout the drive way. The section by the street has large cracks and are separating and lifting. Other cracks are also beginning to show signs of separation. Consult a licensed contractor for further evaluation of the entire driveway and its needs for repair. **NOTE:** It is always recommended to ascertain the installer's credentials/warranty information and/or have the system or component evaluated by a qualified licensed professional.

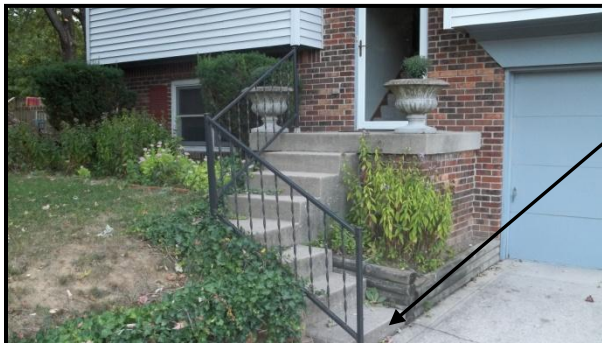
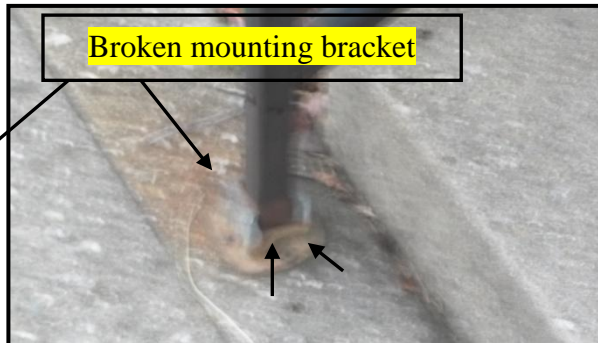
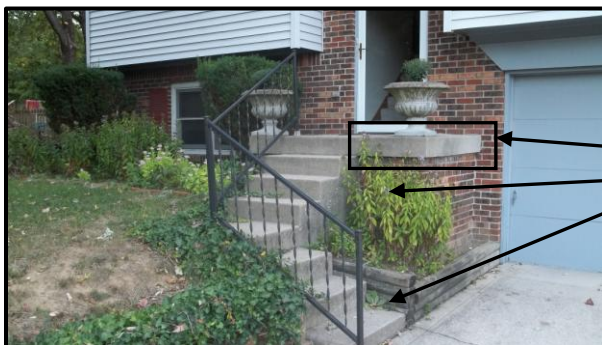
**Steps to Building**

**Comments:** Both handrails at the main entrance of the building are loose. Mounting bracket at the bottom of the stairs is broken and the other 3 brackets need tightening. Hand rail are missing on other side of the stairs and the perimeter of the front porch area. Recommend further evaluation, repairs and installation of missing and damaged rails should be performed by a qualified licensed contractor or specialist.

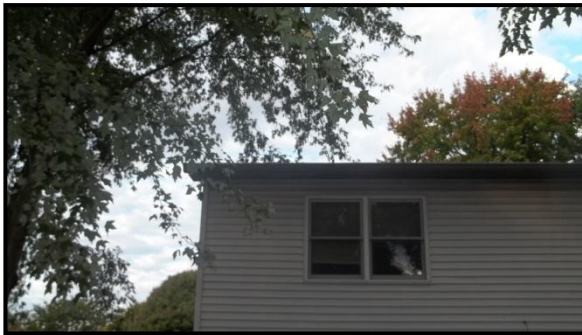
**Trees and Shrubs**

**Comments:** Tree branches are hanging over the roof and rubbing against the south east side of the roof surface. These branches can cause expensive damage to the roof surface. Branches should be cut, to avoid any damage to the roof surface. No damage was observed at time of inspection. Recommend further evaluation and repair be performed by a qualified licensed contractor or specialist.

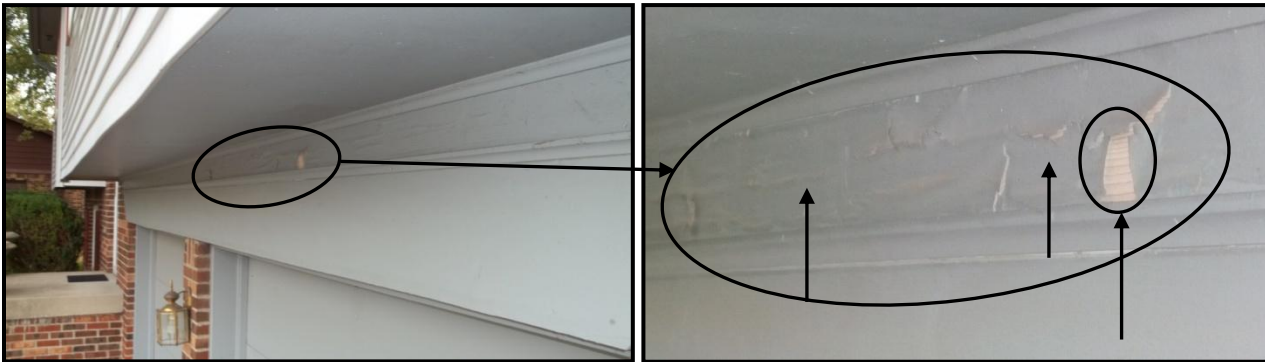
Trim

**Comments:** Paint above the vehicle entry door to the garage is chipping and has exposed wood. Wood was not found to be damaged at the time of the inspection, but some light signs of deterioration were observed. The entire area above the vehicle entry door should be scrapped and repainted to protected wood from the elements and avoid further deterioration. Regular monitoring is recommended after all repairs are completed.

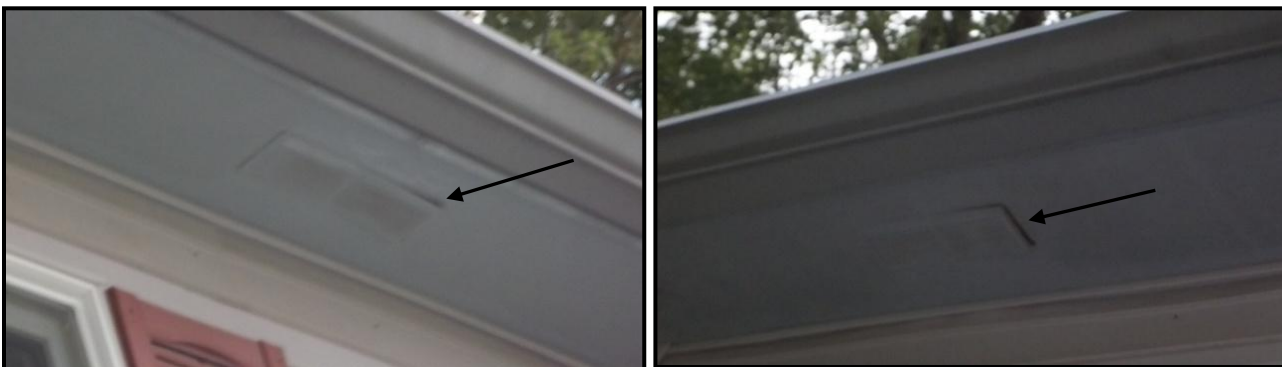
Eaves and Soffits

**Comments:** Soffit vents in the front portion of the building are slightly warped or bent. These gaps could become an entry path for pest into the home or attic area. Recommend these vents be repaired.

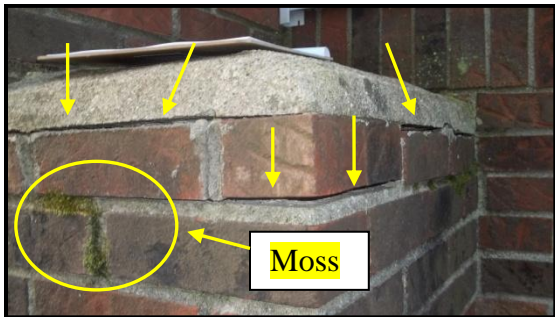
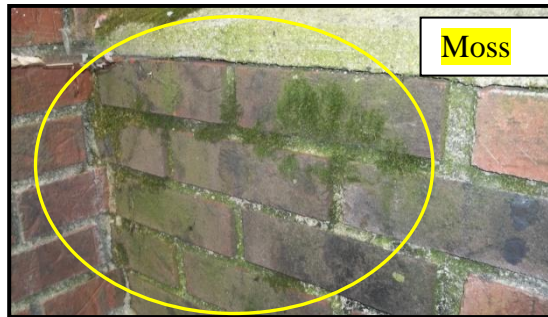
Comments: 1. A brick in a corner of the chimney base area is lifted and loose. Cement over the lower portion of chimney area has separated and lifted also. Recommend further evaluation be performed by a qualified licensed contractor or specialist. 2. Green moss is growing on the brick around chimney. Moss can do some damage to the brick and mortar. Recommend removing and cleaning the area. Moss needs to be removed.

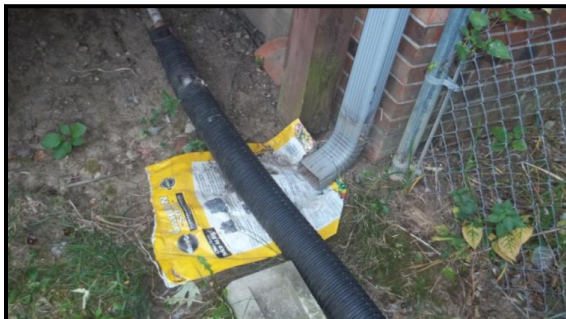
**Gutters and Downspouts**

Comments: Gutter under wood deck on the northeast corner of the building (Back yard) needs an extension. The extension will divert the water from away from the building's structure.

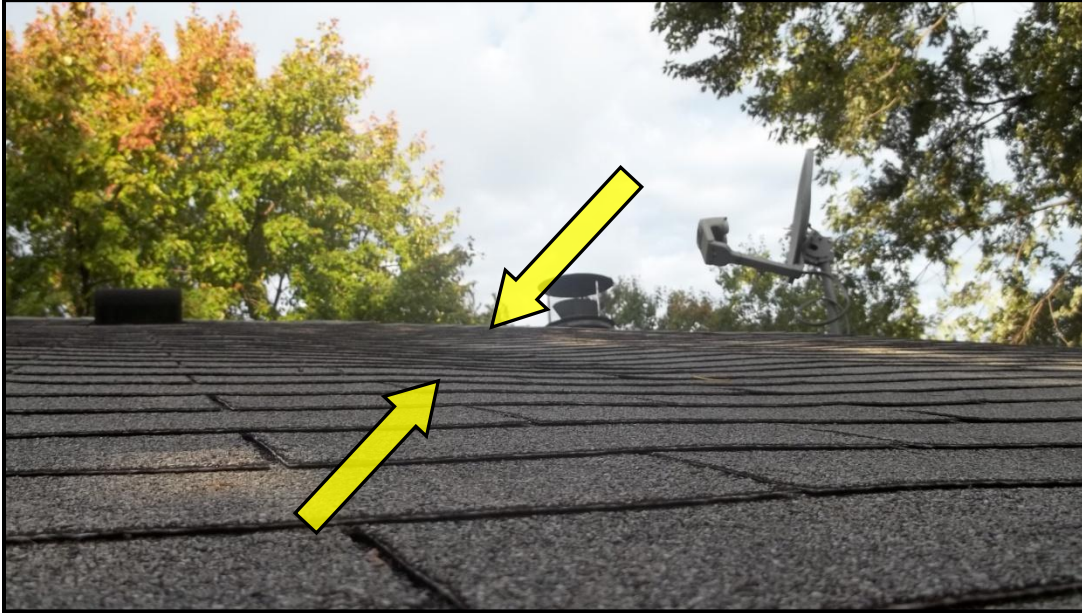
**Comments:** Some warped areas on the roof's surface were observed. Recommend further evaluation be performed by a qualified licensed roofing contractor.

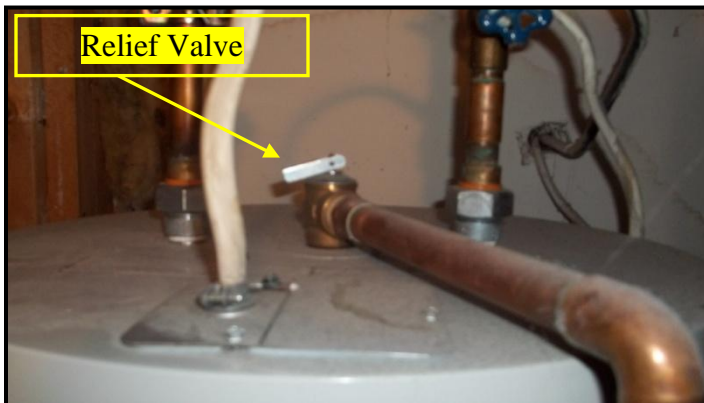
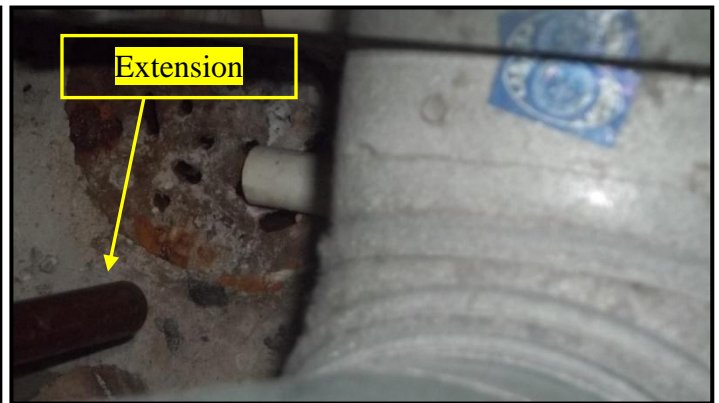
Condition: **SA****Comments:** Extension line is about 6 inches from the ground. Extension line appears closer do to angle of the picture.

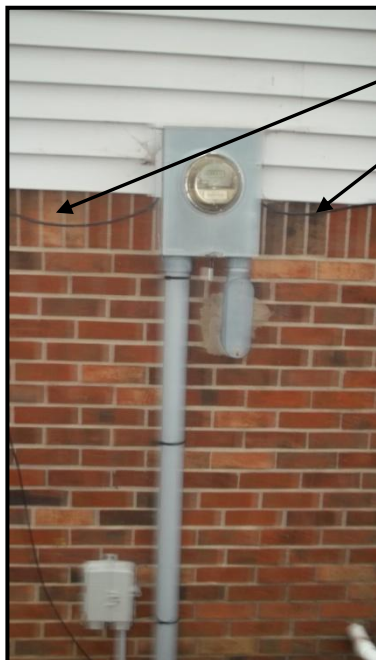
Comments: Unsecured TV cable wire running over service entrance box. Contact cable company, to have wire secured.

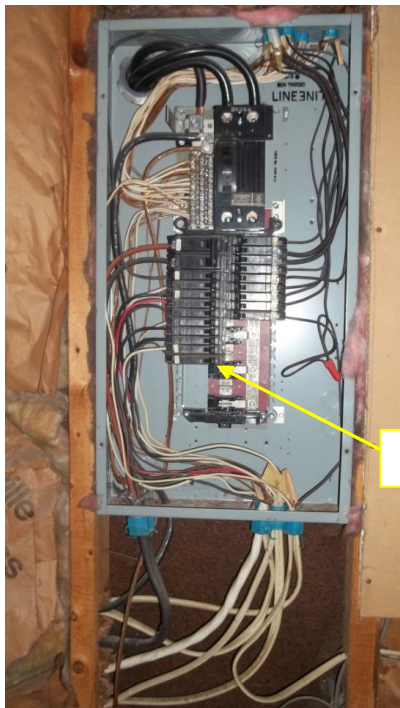
**Loose breaker**

**Comments:** Only 3 breakers were labeled. All breakers should be identified and labeled by a licensed electrician.

**Comments:** Bottom left breaker is loose. (See picture in previous page for detailed picture.) Recommend further evaluation and repairs be performed by a qualified licensed contractor or specialist.

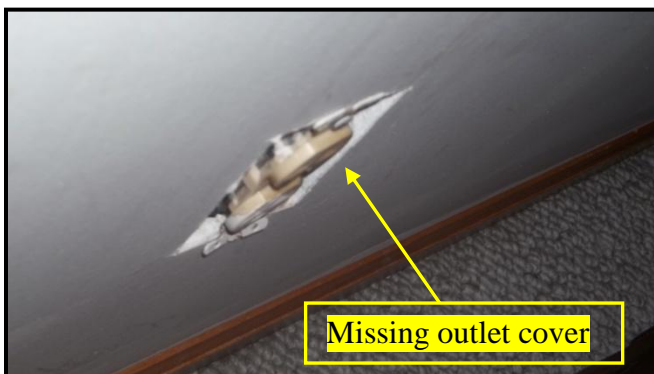
**Comments:** 1. Outlet on the north wall of the living room not working properly. Tester had to be wiggled to get a reading.  
2. Outlet in the family room's south wall is missing the outlet cover. Cover need to be replaced.

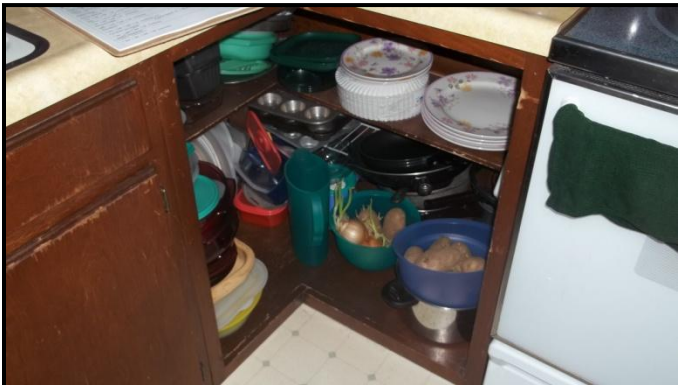
Comments: Door missing from lower cabinet next to the stove.

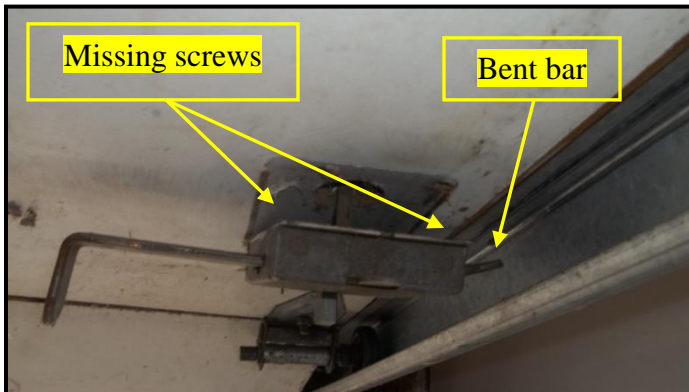
**Comments:** Manual locking mechanism is missing 2 of its mounting screws. Screws should be replaces. Tip of the locking bar is bent.
