# Home Inspection Report

**8605 Same Ct.  
Indianapolis, In 46217**

Date: February 18, 2012

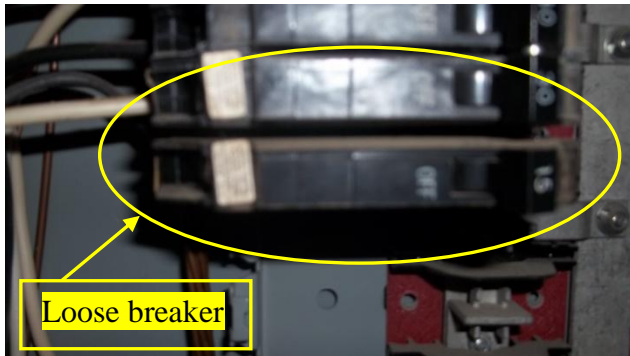
4. Electrical
  - a. Bottom left breaker in the main electrical panel is loose.
  - b. No GFCI Located in the exterior front entry, kitchen. One of two outlets in the garage is not a GFCI.

**Comments:** Bottom left breaker is loose. (See picture in previous page for detailed picture.) Recommend further evaluation and repairs be performed by a qualified licensed contractor or specialist.
